NASA
Technical Memorandum 106621

Prepared for the
Eighth Conference on Advanced Structural Fiber Composites
sponsored by International Conferences on Modern Materials & Technologies
Florence, Italy, July 1-4, 1994

HEAT TREATMENT EFFECTS ON THE TENSILE PROPERTIES AND MICROSTRUCTURE OF A SiC/RBSN COMPOSITE IN NITROGEN

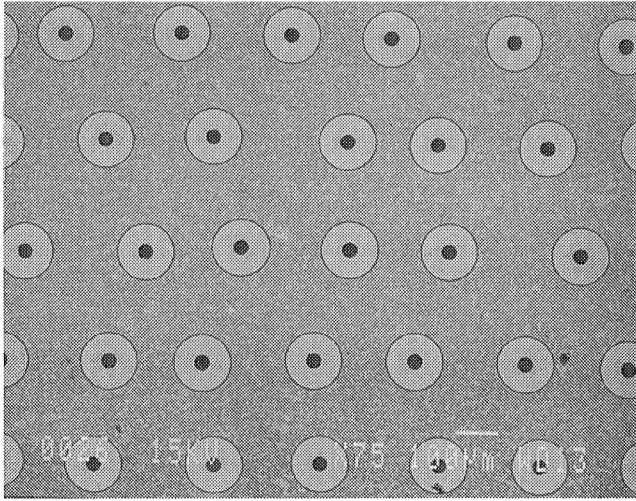
Figure 1.—Cross-section showing microstructure of unidirectional SiC/RBSN composite ($V_f = 24\%$).

A polished cross-section of a typical 24 vol% SiC/RBSN composite specimen is shown in figure 1. The fibers are uniformly distributed in the non-uniform pore size matrix.

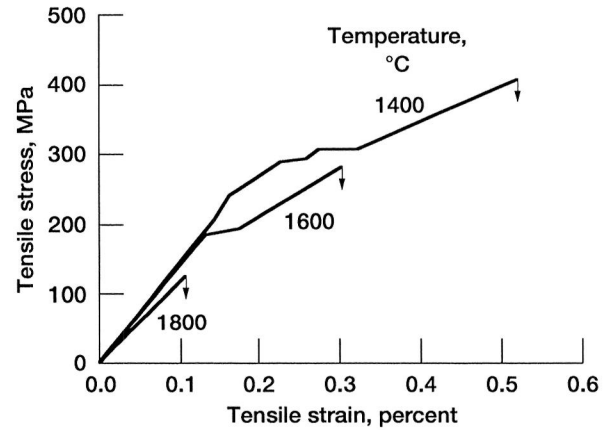
Figure 2.—Room-temperature tensile stress-strain curves of SiC/RBSN composites ($V_f = 24\%$) after 1 hr heat treatment in nitrogen.

The room-temperature tensile stress-strain curves for the 1-D SiC/RBSN composites after 1 hr heat treatment in nitrogen at 1400, 1600, and 1800 $^{\circ}\text{C}$ are shown in figure 2. Since the stress-strain curves of the as-fabricated composite and the composite heat treated in nitrogen for 1 hr at 1400 $^{\circ}\text{C}$ are similar, the stress-strain curve of the as-fabricated composites is not shown in figure 2. The 1400 and 1600 $^{\circ}\text{C}$ curves show three regions: an initial linear elastic region, a non-linear region, and a second linear region. The existence of a non-linear region in the stress-strain curve indicates bridging of matrix cracks by the fibers, and tough composite behavior. The stress-strain curve of the 1800 $^{\circ}\text{C}$ heat treated composite displays an initial linear region and no strain capability beyond matrix fracture. The slope of this line is slightly lower than that of the other two.

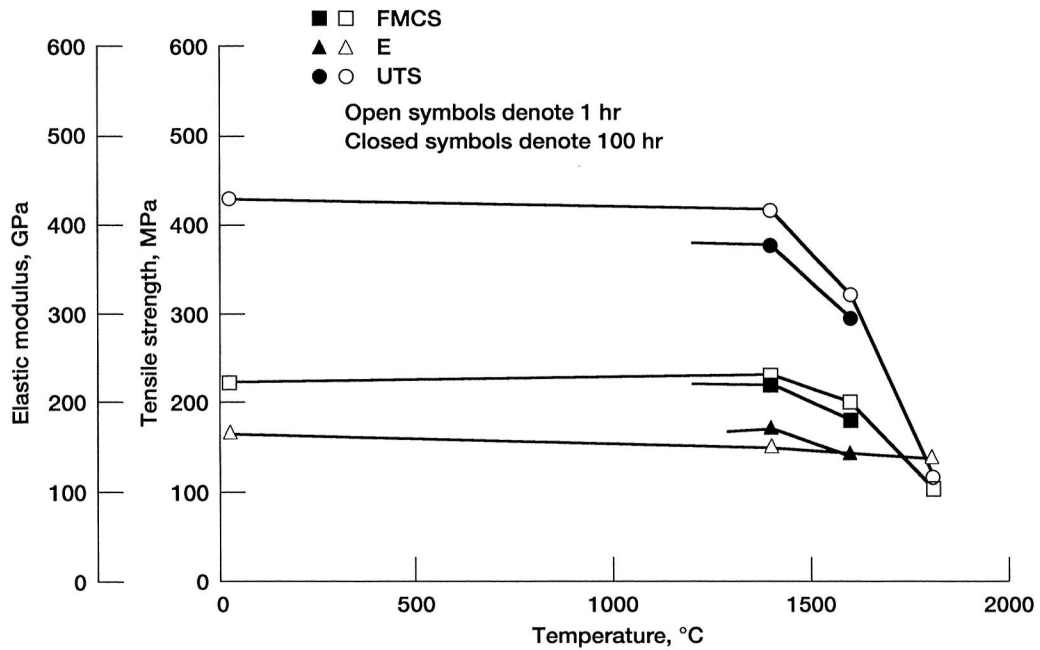
Figure 3.—Effects of heat treatment temperature and time on tensile properties of SiC/RBSN composites.

The effect of 1 and 100 hr heat treatment in nitrogen on primary elastic modulus (E), first matrix cracking stress (FMCS), ultimate tensile strength (UTS) of the composites are illustrated in figure 3. Each data point represents an average of three tests. Since the specimens heat treated at 1800 $^{\circ}\text{C}$ for 100 hr were very weak, their tensile data could not be plotted in figure 3. As seen in the figure, for up to 100 hr of exposure at 1400 $^{\circ}\text{C}$, the composites retained as-fabricated mechanical properties. With increasing temperature of exposure the elastic modulus, the first matrix cracking strength, and the ultimate tensile strength decreased, but the ultimate tensile strength showed greater loss with exposure temperature than did the matrix fracture strength or the elastic modulus.

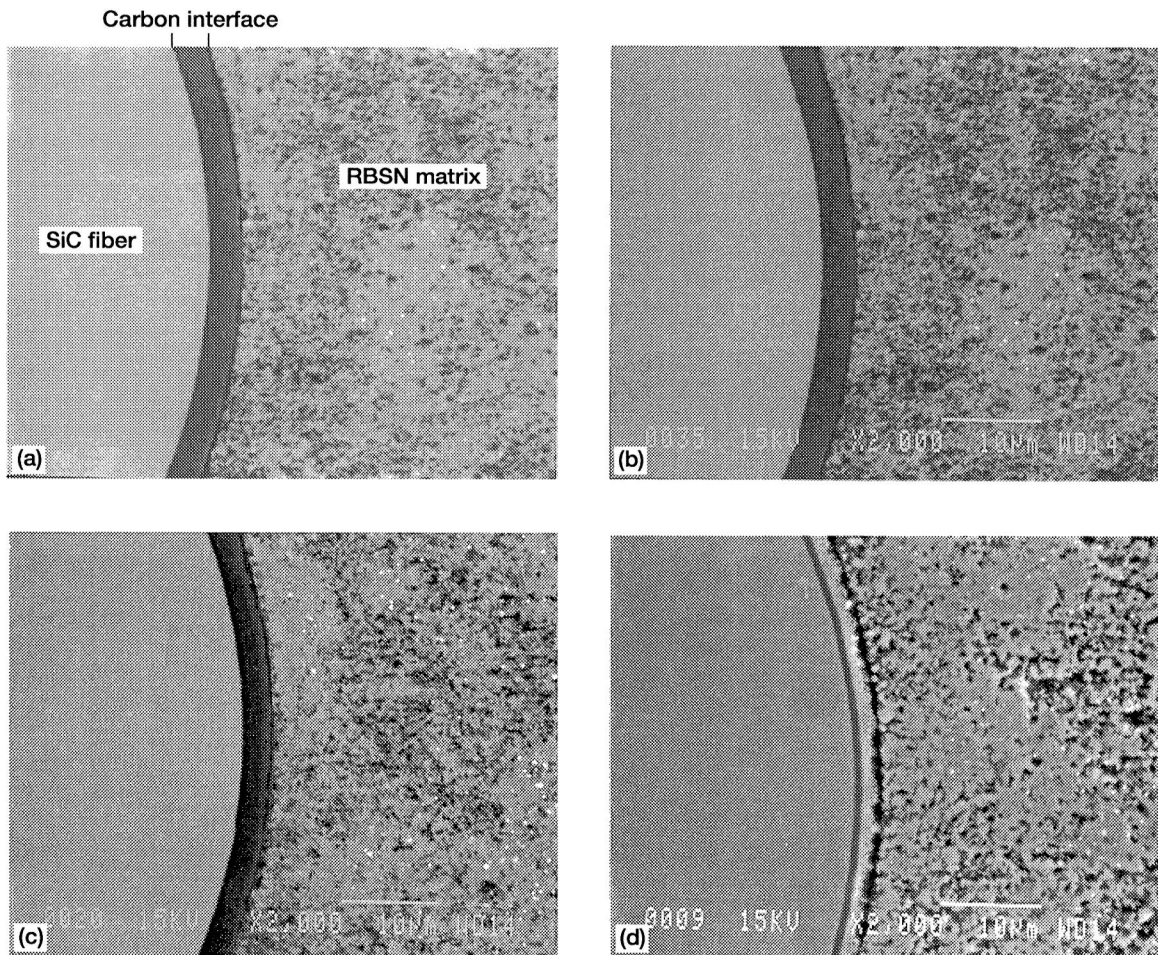
Figure 4.—Influence of one-hr heat treatment in nitrogen on microstructure of SiC/RBSN composite. (a) As-fabricated. (b) 1400 °C. (c) 1600 °C. (d) 1800 °C.

Examination of the cross-sections of the heat treated composites indicates that up to 1600 °C, the RBSN matrix and carbon-rich interface coating remained stable (fig. 4(c)). Beyond this temperature, the carbon-rich interface coating reacted with the RBSN matrix (fig. 4(d)). As a consequence, the thickness of the carbon coating is ~ half that of the as-fabricated composite. In addition, the size of the matrix pores has increased. Limited x-ray measurements performed on composites heat treated at 1800 °C showed increasing amounts of silicon in the RBSN matrix with increasing exposure time. Increasing amounts of silicon in the RBSN matrix indicates dissociation of silicon nitride to silicon and nitrogen. In fact, it is known that silicon nitride dissociates at ~ 1800 °C in 0.1 MPa nitrogen (ref. 11). Composites heat treated for 1 hr at and beyond 1600 °C also showed fiber degradation. A diffusion zone started emanating from the outer surface of the SiC fiber adjacent to the carbon-rich surface coating. The thickness of this zone increased with increasing temperature of exposure or with increasing time of exposure at a given temperature. A photomicrograph of the cross section of the composite heat treated at 1800 °C for 1 hr showing the growth of the zone is shown in figure 5. The growth of the diffusion zone at the interface of the carbon coating and the SiC sheath is similar to that observed in the individual SiC fibers heat treated beyond 1500 °C for 1 hr in an argon environment (ref. 12), but the thickness of the zone in the composite is smaller than that in the individual fibers. It has been shown by TEM analysis of heat treated SiC fibers that the diffusion zone consists of equiaxed recrystallized SiC grains (ref. 12). This study showed that strength degradation in this fiber is due to recrystallization and growth of SiC grains and that a relationship exists between the strength of the heat treated fibers and the thickness of the recrystallization zone.

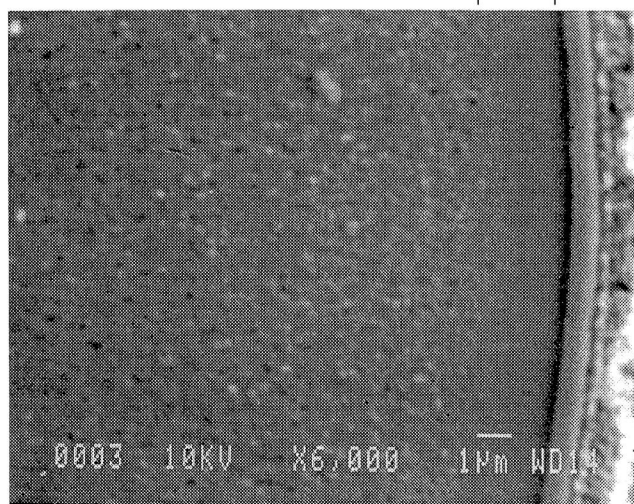
Recrystallization zone

Figure 5.—Photomicrograph of cross-section of SiC/RBSN composite heat treated at 1800 °C for 1 hr showing growth of diffuse zone at interface of carbon coating and SiC sheath of SiC fiber.
